A Review on the Impact of Icing on Aircraft Stability and Control.

Abstract

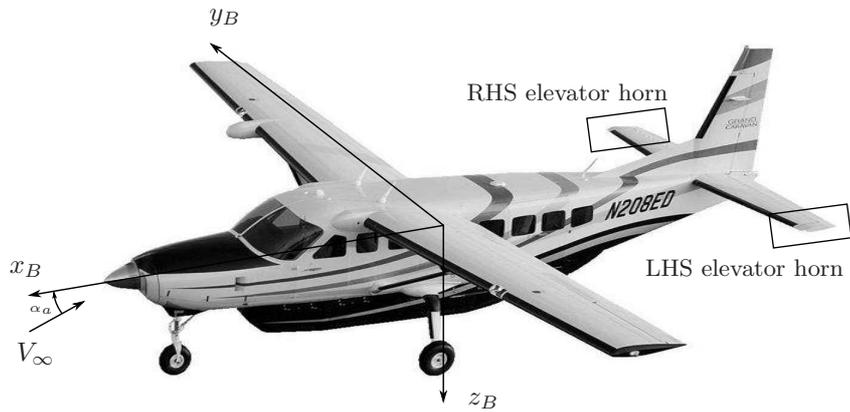
Figure 1: Indication of the elevator horn balances on the aircraft and the orientation of the body-axis reference frame (x_B, y_B, z_B) and the aircraft's angle of attack α_a .¹

A particular element of small general aviation aircraft that can act as a destabilizing source mechanism is the *elevator horn balance*. The elevator horn balances are located at the tip of the horizontal stabilizers as indicated in figures 1, 2 and 3. The elevator horn balance acts as an aerodynamic/mass balance that lowers the pilots control force needed to deflect the elevator and alleviates low flutter speeds associated with control surfaces found in reversible control systems. The aerodynamic chord of the horn balance, c_h , is relatively long when compared to the control horn span, b_h ; that results in a significant overhang and exposure of the leading edge of the horn balance to the freestream flow when the elevator is slightly deflected. This is the case during, for example, a climb maneuver or flare just before touchdown, which are the phases of flight where most of the accidents occur [3, 4, 5].

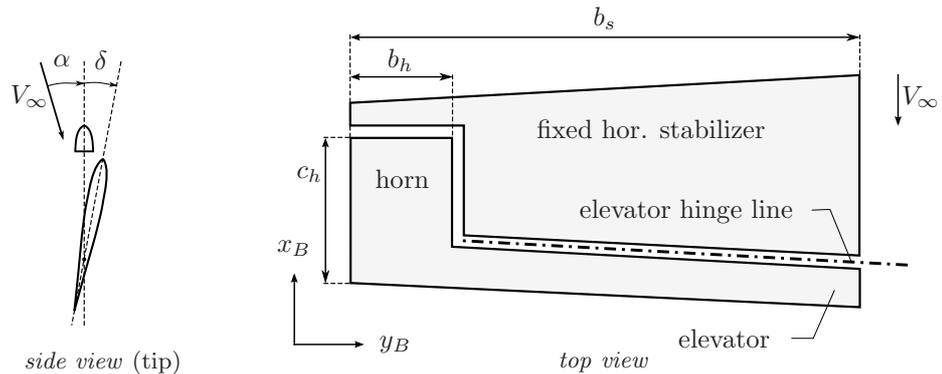
Figure 2: (top view) Schematic of LHS horizontal stabilizer and the location of the elevator and horn balance, (side view) the angle of attack α of the horizontal stabilizer and the elevator deflection angle δ .

Most of the reversible control surface systems employ a combined aerodynamic and mass balance horn, incorporated in an external control surface as was indicated in figures 2 and 3. This horn balance alleviates low flutter speeds associated with control surfaces found in reversible control systems. In the de-icing philosophy of ice protection on horn balances no inflatable de-icing boots are employed since their activation causes significant control hinge moment variations upsetting the aircraft trim conditions in cruise flight.

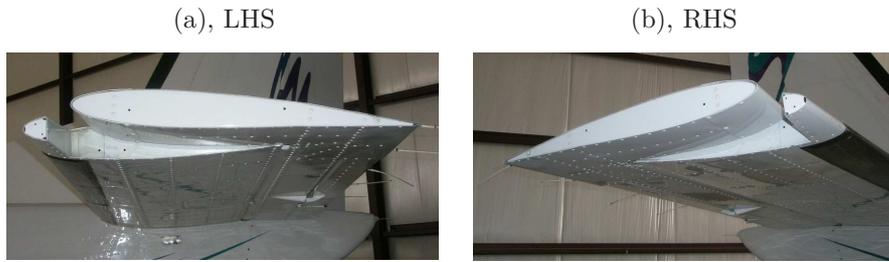
Figure 3: Elevator horn balances on a small general aviation aircraft.

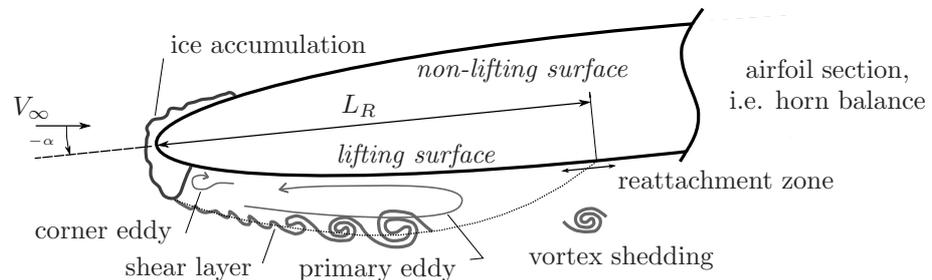
Figure 6: Schematic of the ice-induced separation bubble on an airfoil with leading edge ice accumulation, following the work of Gurbacki *et al.* (2004) [13].

Several studies have been performed on the actual effects of (simulated) ice deposit on the leading edges of airfoils [12, 13, 14, 15]. A schematic indicating the typical flow features around an airfoil with leading edge ice formation is shown in figure 6. The air flow around the ice horn on the lifting surface of the airfoil separates due to an adverse pressure gradient. Downstream of the ice horn a primary eddy and corner eddy are present followed by a reattachment region and a vortex shedding event from the shear layer. The characteristics are consistent with the well-studied backward-facing step flows such as in review by Eaton & Johnston (1981) [16] and as presented in the study by Bradshaw & Wong (1972) [17].

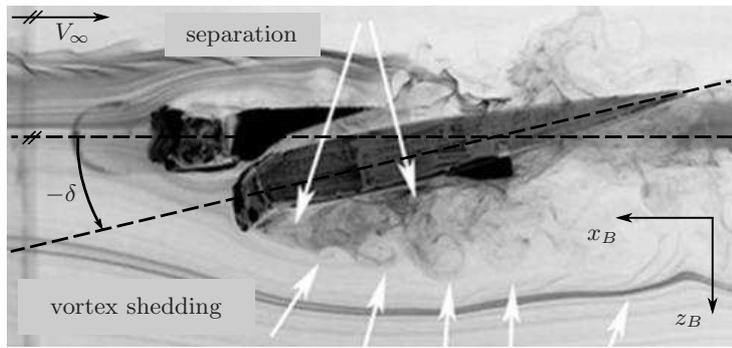
Figure 7: Flow visualization over a $1/10^{\text{th}}$ scale LHS horizontal stabilizer with elevator horn balance using a smoke wire sheet producing a 2d smoke sheet (*side view*), $\alpha = 0^\circ$, $\delta = -8^\circ$, $Re_{c_h} = 1.7 \cdot 10^5$ [20].

A qualitative wind tunnel visualization study was conducted at UT Austin [20] to validate the occurrence of unsteady flow events downstream of the ice accumulation. Figures 7 and 8 indicate the span wise vorticity structures and the flow separation over the horn balance for $\alpha = 0^\circ$ and $\delta = -8^\circ$. It was observed that the two dimensional span wise vorticity signatures were still present although highly three dimensional flow effects were observed at the stabilizer tip.

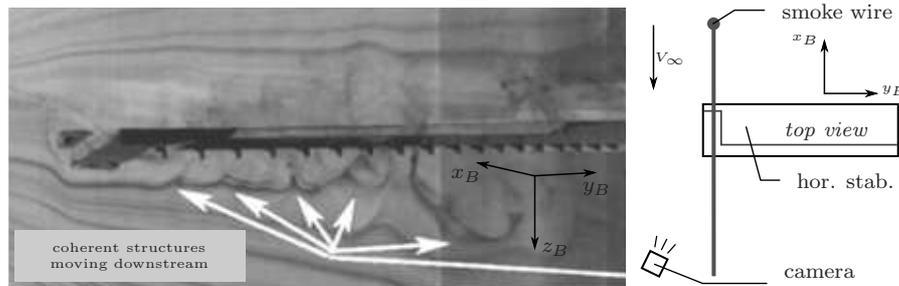
Figure 8: Flow visualization over a $1/10^{\text{th}}$ scale LHS horizontal stabilizer with elevator horn balance using a smoke wire sheet producing a 2d smoke sheet (*oblique view*), $\alpha = 0^\circ$, $\delta = -8^\circ$, $Re_{c_h} = 1.7 \cdot 10^5$ [20].

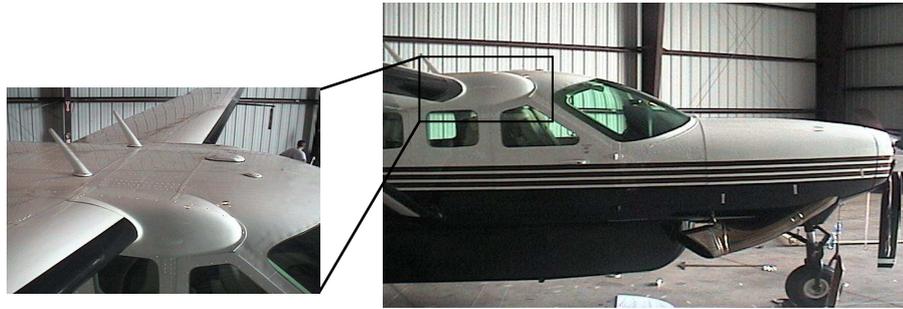
Figure 9: A 'shoulder' located at the wing/fuselage junction on the RHS of a small general aviation aircraft.

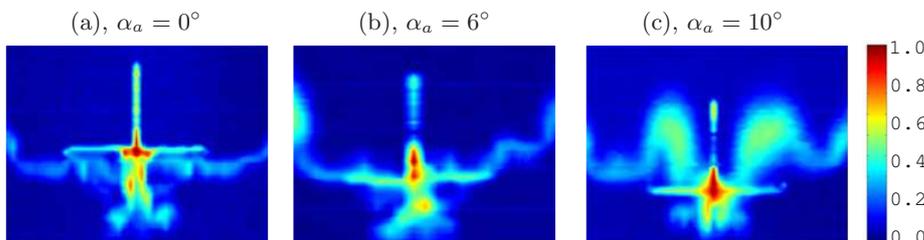
Figure 10: Contours of the total pressure ratio $1 - p/p_\infty$ behind a $1/32^{nd}$ scale model of a small general aviation aircraft, $Re_{\bar{c}_{wing}} = 85,000$ [22].

Water tunnel studies have been performed by Stearman *et al.* (2005) [22] on a representative $1/32^{nd}$ scale aircraft model to confirm the existence of the wing root vortex pair. Similar studies were performed in the low-speed wind tunnel facility of UT Austin where quantitative total pressure contours were acquired with a total head pressure rake [22]. The vortical regions show up as low pressure zones. At $\alpha_a = 0^\circ$ (α_a is the aircraft's angle of attack, see figure 1) the vortex pair would trail below the horizontal stabilizers, as indicated in figure 10a. When increasing the angle of attack to $\alpha_a = 6^\circ$, the vortex pair would trail at the same level as the location of the horizontal stabilizers, shown in figure 10b. For $\alpha_a = 10^\circ$ the vortex pair is clearly located above the horizontal stabilizers and next to the vertical tail as shown in figure 10c. Furthermore, it was observed that when the aircraft is in a conventional landing approach or climbing mode the vortex pair would be above the horizontal stabilizers and next to the vertical stabilizer as well [6].

The EA-6B Prowler, a twin-engine, electronic warfare aircraft, was exposed to stability and control upsets that were related to the pair of wing root vortices. Visualization studies were performed by Jordan, Hahne, Masiello & Gato (referenced by Bertin & Smith (1989) [30]) indicating that a pair of vortices was generated at the wing root leading edge. At low angles of attack those vortices were located below the horizontal stabilizers, as presented in figure 17a. At angles of attack below the stall angle the vortex pair trailed at the same location below the horizontal stabilizers due to the wing downwash. However, at angles of attack close to the stall angle, where the downwash effect of the wing was significantly reduced by the flow separation over the wing, the vortex pair was located above the horizontal stabilizers next to the vertical stabilizer as indicated in figure 17b. In case of a slight side slip, i.e. due to a gust, the vortex pair would flip over to one side of the vertical stabilizer, as indicated in figure 17c. The vertical stabilizer may now be exposed to a net force acting to the left hand side (low pressure zone in the vortex core). This has a direct impact on the directional stability of the aircraft by causing a yaw motion that can result in the stall of the right wing, because the aircraft's attitude was already close to the stall angle, causing a roll motion and thereby initiating the wing rock event. It is claimed that the EA-6B and the small general aviation aircraft having those wing root leading edge 'shoulders', have similar vortex interactions with the aircraft tail planes. This is claimed to be due to the fact that both wing root vortices originate from their wing root leading edges. In section 3.1 the pair of wing root leading edge vortices was introduced. Those wing root vortices are then shown to trail off from this wing root leading edge passing over the wing and ending up next to the vertical stabilizer as was shown in figure 10.

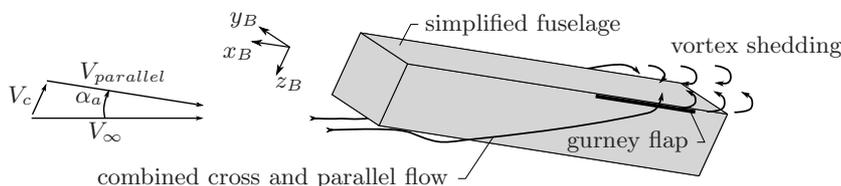
Figure 11: Schematic of the cross flow around a simplified fuselage at a positive angle of attack α_a (note that the longitudinal edges of the fuselage are rounded in reality).

It was also concluded that a resulting violent wing rock motion occurred when the wing trailing vortex pair broke loose from the aerodynamic chines resulting in a fuselage cross flow vortex shedding motion, as was presented in figure 11. A study has been conducted at UT Austin on a $1/10^{th}$ scale, powered, radio-controlled, dynamic-cable-mounted, 6 DOF model, shown in figure 18. The observed fuselage cross flow shedding frequency of approximately

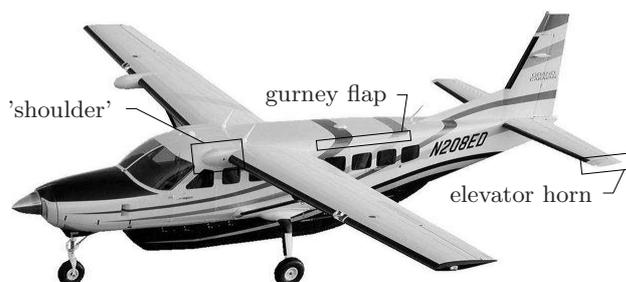
Figure 12: Indication of the 'shoulder', gurney flap and elevator horn balance on the LHS of a small general aviation aircraft.

The last important characteristic concerning the discussion of the upset events are the drip plates mounted above the rear doors of the fuselage as indicated in figure 12. Those drip plates act as gurney flaps relative to the cross flow, to ensure that the separation points of the cross flow around the fuselage are fixed. The cross flow V_c occurs when the aircraft is flying at a positive angle of attack, $\alpha_a > 0^\circ$, as schematically indicated in figure 11. The trailing edge vortical unsteadiness originating from the wing root is further aggravated when the fuselage chines or drip plates, holding these root vortices to the fuselage, also ice up. The ice deposit blunts the sharp aerodynamic chines, which can then no longer hold these two wing root trailing vortices to the fuselage. This will produce two alternately moving separation points.

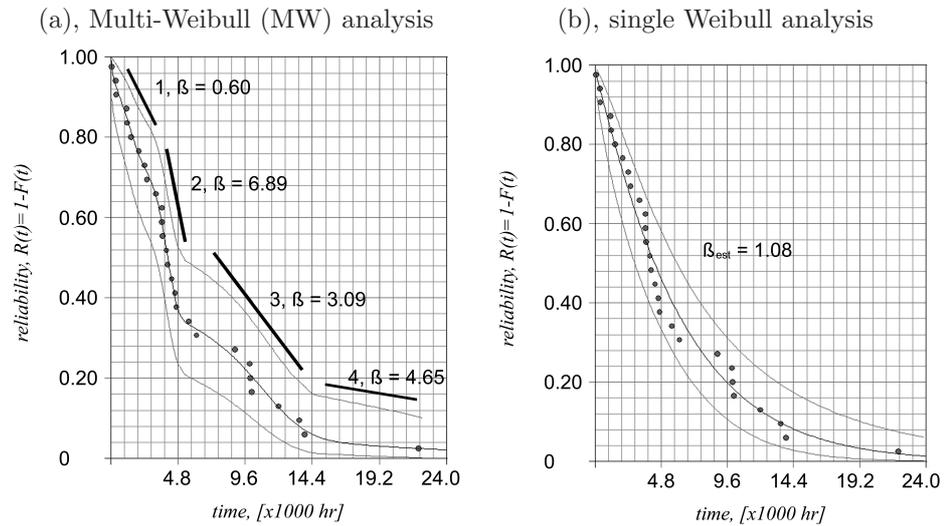
Figure 13: Weibull failure analysis of the published NTSB icing accident data, figure (a) indicates the identification of four failure modes with its respective slopes β . Generated by ReliaSoft's Weibull++ 5.0 software.

An estimate of the overall reliability of this representative general aviation aircraft, when flying in icing conditions, is shown when estimated by the MW approach in figure 13a, demonstrating an estimated four failure modes in the 28 point dataset. The slope β of the first and most critical Weibull line is 0.60 which is seen to lie well within the 'infant mortality' or 'early failures' region of the bath-tub curve. The other three failure modes lie outside the 'infant mortality' failure zone into the 'wear out' region. Finally, a typical Weibull failure analysis using a single line slope estimate, produces the reliability function illustrated in

figure 13b. The resulting "dog legs" in this reliability estimate of the 28 point dataset suggest at least four failure modes as well. The slope β of this single Weibull line approaches the random failure slope of 1.0. The estimated value is close to this, being $\beta_{est} = 1.08$, as shown in figure 13b. Since multi-failures are admitted, the single line analysis is suggesting that any of the multiple failures could occur randomly across any of the possible failure modes.

The category II "wing rock upset" in the present study was identified to be the first failure mode in figure 13a. The first point of 80 hours airframe time at upset and the point at airframe time of 3,227 hours at upset have specific been identified as observed violent aircraft upsets of the wing rock type. This upset described earlier under the pilot and witness reports has been observed in a number of accidents by several witnesses and has been experienced by at least

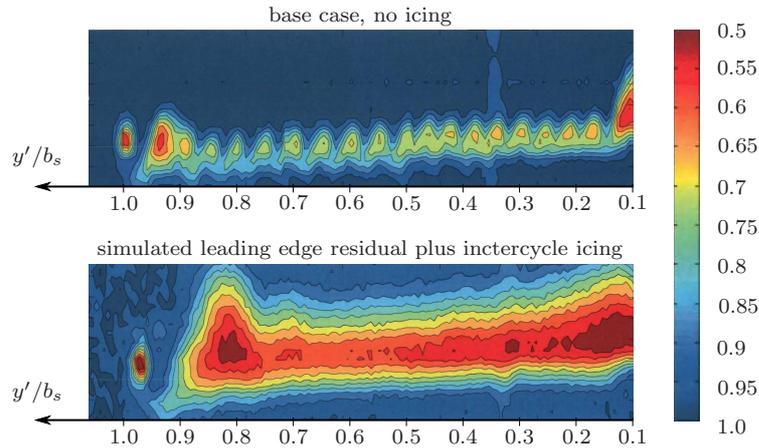
Figure 15: Contours of the total pressure ratio p/p_∞ behind a $1/10^{th}$ scale horizontal stabilizer [27], $\alpha = 6^\circ$, $\delta = 0^\circ$. $Re_{c_h} = 1.1 \cdot 10^5$.

in figure 15. A total head rake was run along the trailing edge of the stabilizer of our $1/10^{th}$ scale model with vortex generators to check the presence of the spanwise vorticity generated by the vortex generators. Figure 15 (top) illustrates a clean stabilizer where the generated vortices of each vortex generator is clearly seen in good detail. When simulated residual plus intercycle icing is applied to the stabilizer, as shown in the lower left corner of figure 16, a complete cancellation of the organized vorticity from the vortex generators is observed as shown in figure 15 (bottom). An examination of figure 16 suggests that an overlay of spanwise vorticity, shed off the ice-induced shear layer, is interacting with the orthogonally created vorticity by the vortex generators. In essence, the orthogonal overlay of these two distinct vorticity fields cancel each other. This action then nullifies the benefit of the vortex generators creating a loss of elevator pitch down control authority induced by icing conditions. In summary, if a LCO is also occurring, driven by the elevator iced up horns, as in the case of the category I upset, a much stronger spanwise bound vorticity is being shed which will certainly annihilate the benefit of the vortex generators. A complete loss of elevator control authority is then expected.

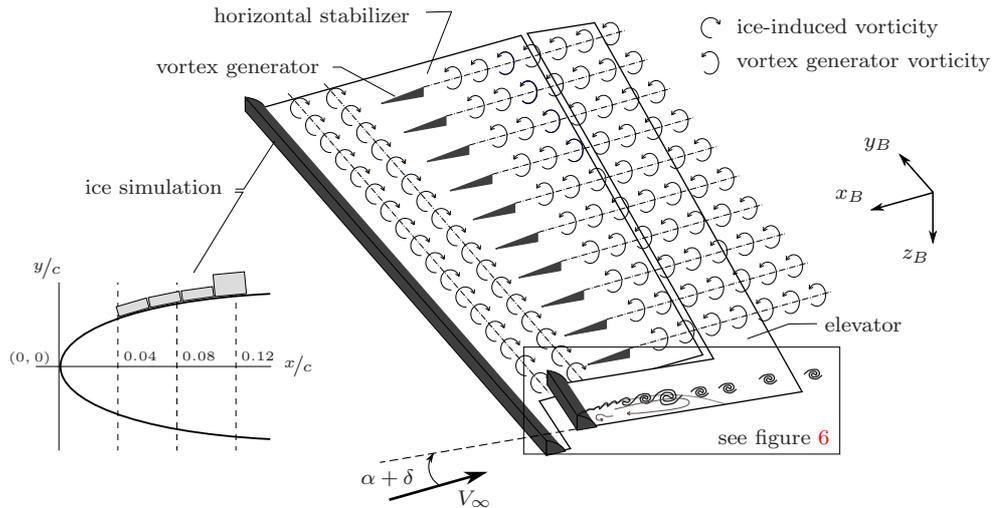
Figure 16: Schematic of the interaction between the ice-induced vortex field and the vortex field created by the vortex generators on a LHS horizontal stabilizer. The simulated ice accumulation that was used in the experiment at UT Austin is shown in the lower left corner [27].

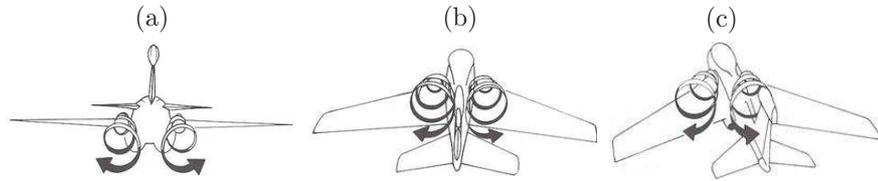
Figure 17: Directional destabilizing mechanism of the wing root vortex pair on the EA-6B [30].

Highspeed camera screenshots, presented in figure 20, indicate that the wing root vortices become very violent when the lock-in occurs, as they flip over to the other side. In this study by Endruhn *et al.* (2006) [6] it was also shown that if the aerodynamic chines or drip plates were extended back along the fuselage to about 0.5m (in full-scale size) forward of the leading edge of the horizontal stabilizers, the wing rock instability was suppressed. In essence, the highspeed video taping of this event also indicated that the extended chines actually hold the vortices down and away from the vertical stabilizer, so no cross flow can induce yawing and rolling of the aircraft as shown in figure 17c of the EA-6B aircraft.

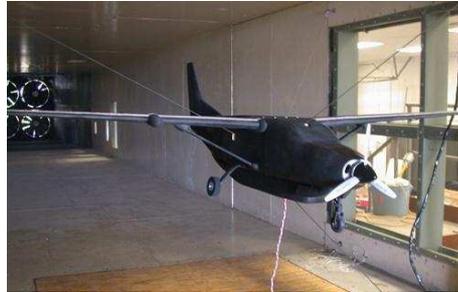
Figure 18: Cable-mounted model in the low-speed wind tunnel facility [27].

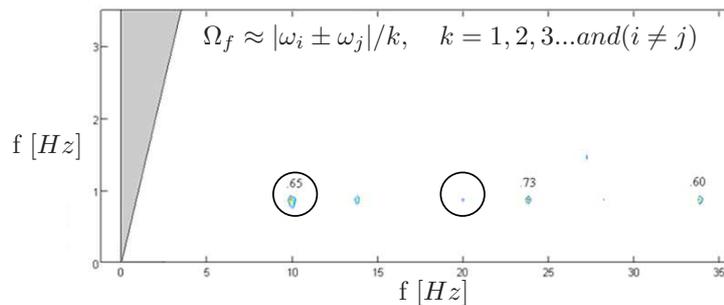
Figure 19: Cross-bicoherence function of the pressure transducer and z-component of the accelerometer when ice was simulated on the elevator horn balance leading edges [6]. Ω_f and ω indicate the frequencies of respectively the acceleration and pressure events.

1Hz locked-in with the unsteady separated flow frequencies of 10Hz and 20Hz over the elevator horn balances, caused by the simulated ice accumulation, in a combination resonance mode. To deal with the nonlinear aspects of these vortex dynamic interactions, Higher Order Spectra (HOS) analysis techniques [31, 7] were used in the signal processing employed in the wind tunnel testing. Although the ice-induced unsteady flow phenomenon had different frequencies (measured using a pressure transducer near the elevator horn balance as 10Hz and 20Hz) and the Dutch Roll wing rock frequency (measured using accelerometers as 1Hz), it was concluded based upon cross-bicoherence analysis, that a lock-in of these three separate frequencies occurred in a quadratic sense, only when icing was present on the horn balance leading edges [6]. Figure 19 presents a plot of the cross-bicoherence function illustrating these events by demonstrating spectral peaks at coordinates of 10Hz and 1Hz as well as at 20Hz and 1Hz. It is evident from figure 19 that other interactions also appear possible.

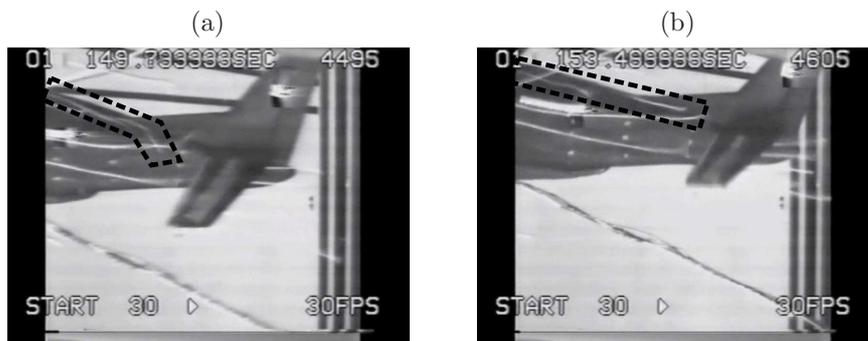
Figure 20: Highspeed camera screen shots showing the violent wing root vortices. The boxes highlight the tuft, attached to the farside of the fuselage, aft of the trailing edge, flipping over to the nearside.
